Saturn B/M – Main Control Unit Fan

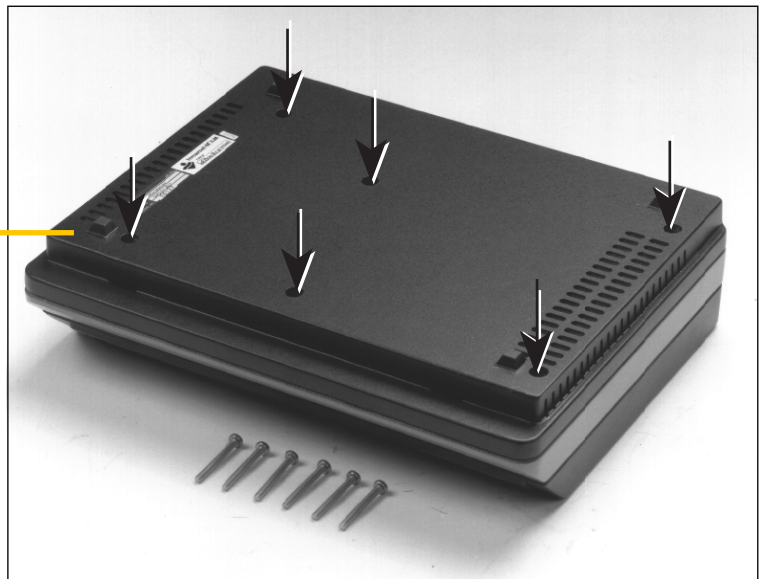
MCU bottom cover

The Main Control Unit (MCU) cooling fan has in some cases stopped, giving the following symptoms:

- Message appears in the display: "**Temperature too high**".
- The internal temperature sensor has turned off the MCU automatically.

The fan rotor must be cleaned and lubricated:

1. Place the MCU with the bottom side facing up.
2. Unscrew the bottom cover.
3. Using a small brush, remove dust and dirt from the fan rotor.
4. Pull off the rubber end piece w/bearing.
5. Clean the shaft end and lubricate sparsely with dry silicone grease.
6. Reinsert the end piece.
7. Remount the bottom cover.

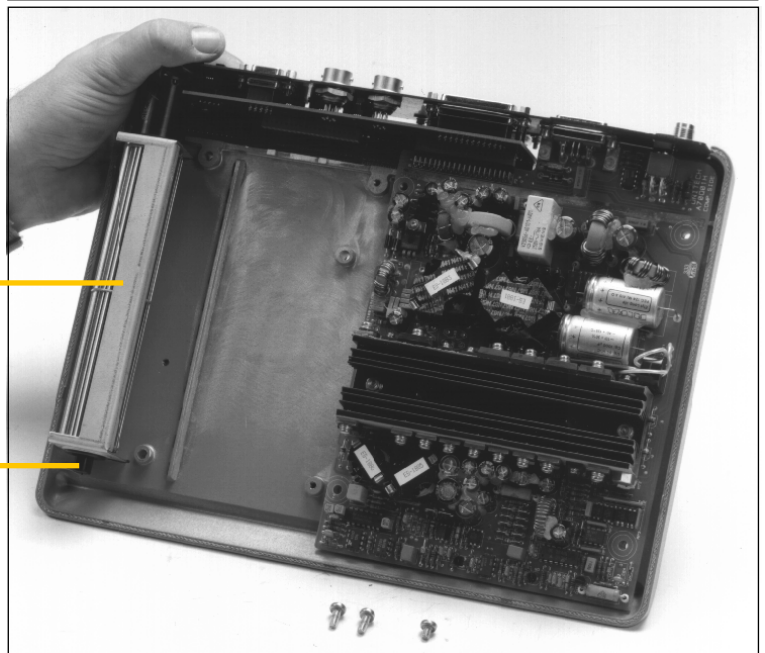
Cooling fan

Rubber end piece
